Heritage Committee Meeting Agenda

HERITAGE REPORT

O'BRIEN HOUSE

458 STE. MARIE STREET, COLLINGWOOD

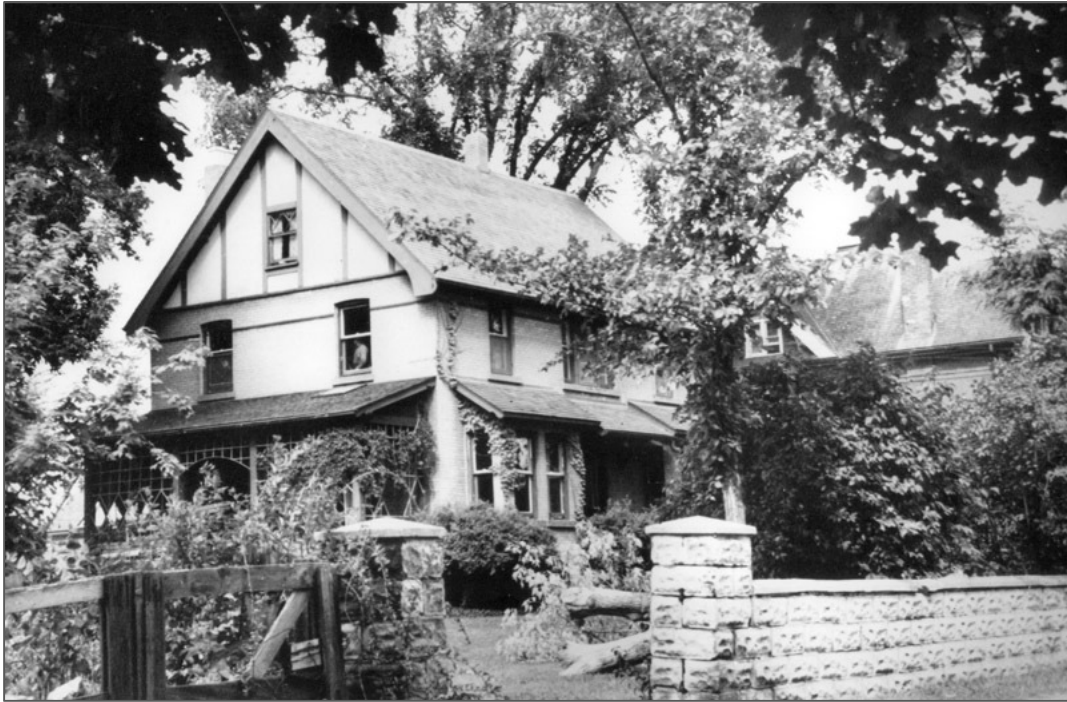
These two images were provided by George Christie (2010 owner). He believes both date to just after his uncle and aunt, Edward and Eileen Smart, bought the property in August 1950. Based on the amount of overgrown vegetation and the trellis in the south verandah, the top image appears to be earlier than the bottom image. Both are before any significant changes were made to the structure.

A band of moulded wood trim applied to the masonry just below the eaves is visible in the 1950s images and in 2010. The foundation is rubblestone. The existing chimney replicates the original.

In the 1950s, the stairway led to a landing with a handrail and support posts. The front doorcase and the landing have been remodelled and/or replaced.

The 1917 insurance plan indicates a south facing verandah. An entryway within this open verandah is shown in the 1950s images. This verandah has been enclosed and the wood steps replaced with concrete. The doorcase has been replaced.

The second storey, centre window opening on the east facade appears in the 1950s images to be in three parts: a centre sash with a narrow sash on each side. Although since replaced with three sashes, the centre sash is still the widest.

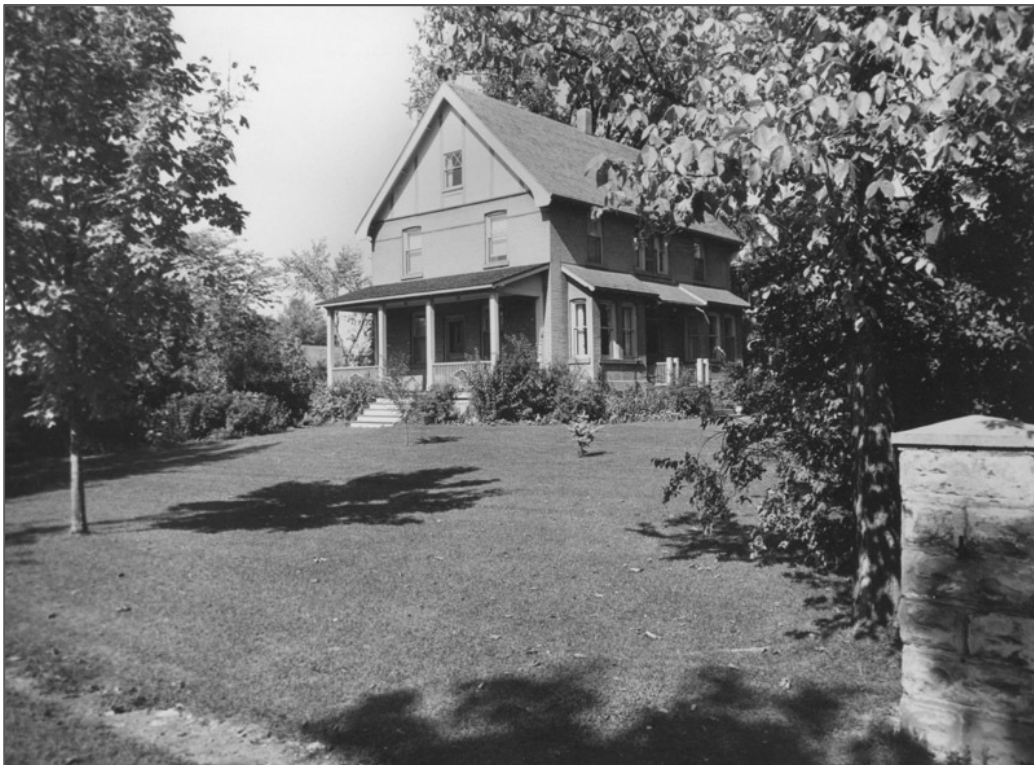
Above: East facade (R); south facade showing enclosed verandah (L)

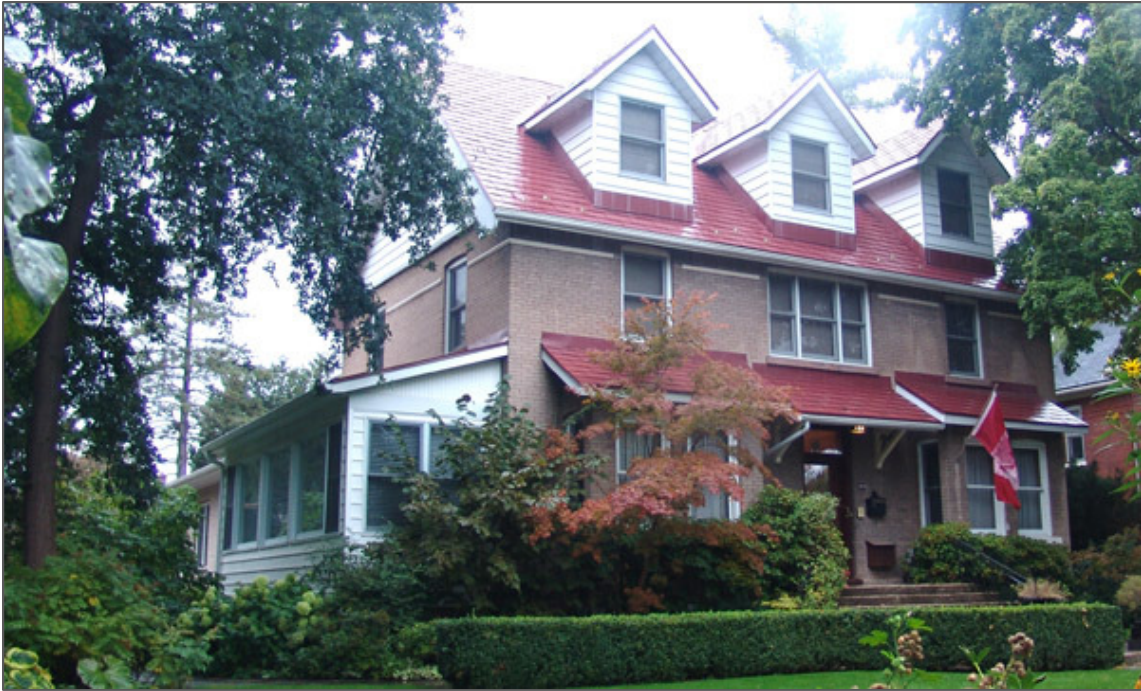
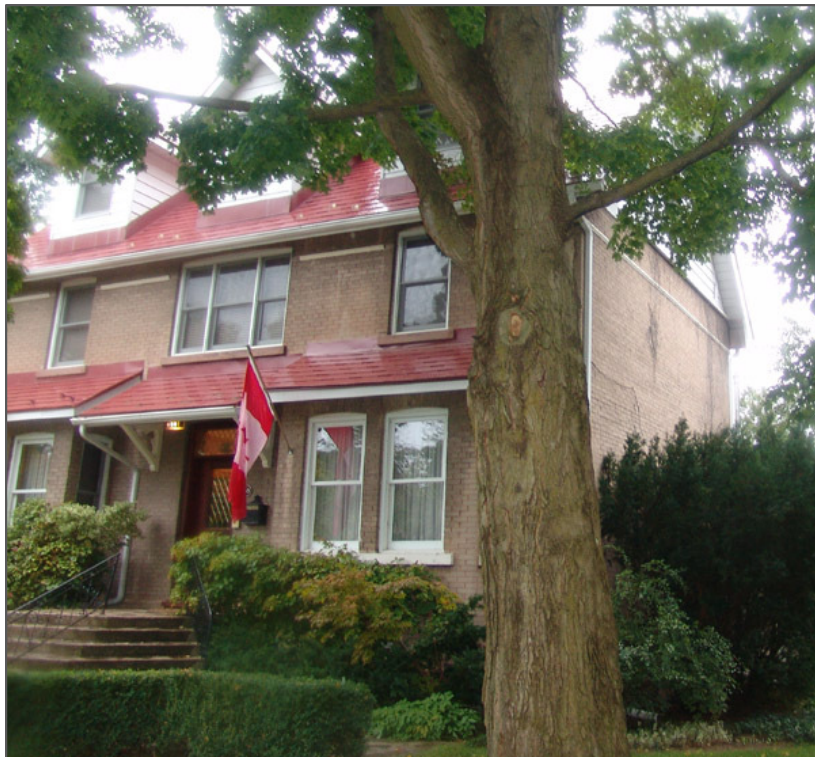
Below: East and north facades

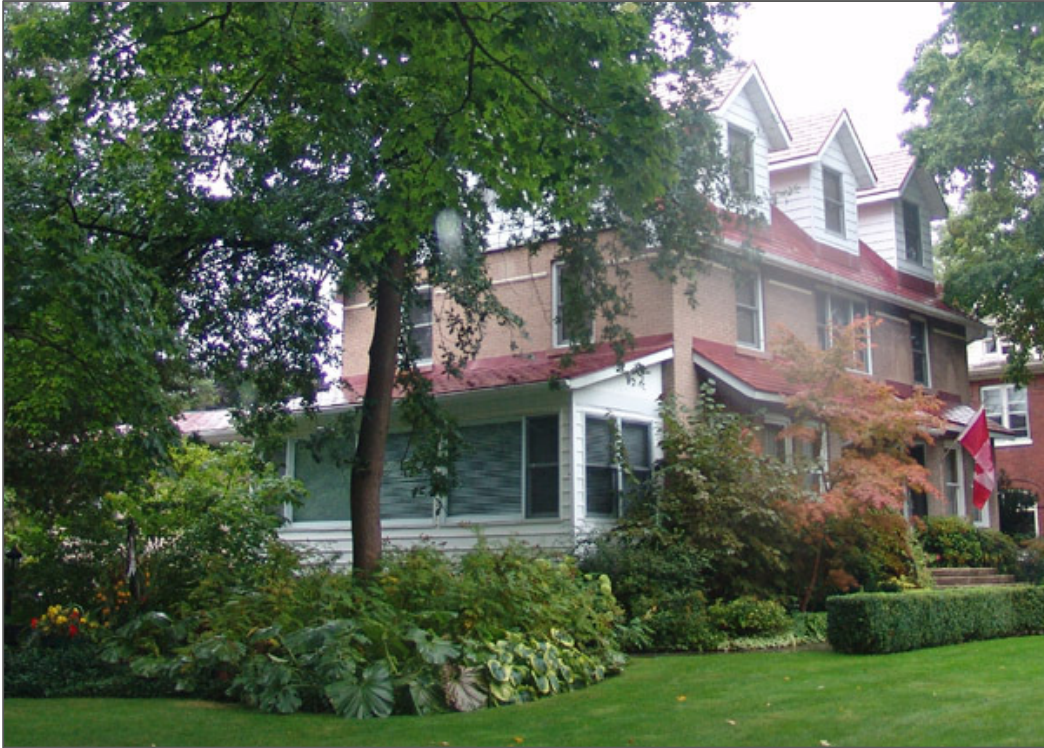
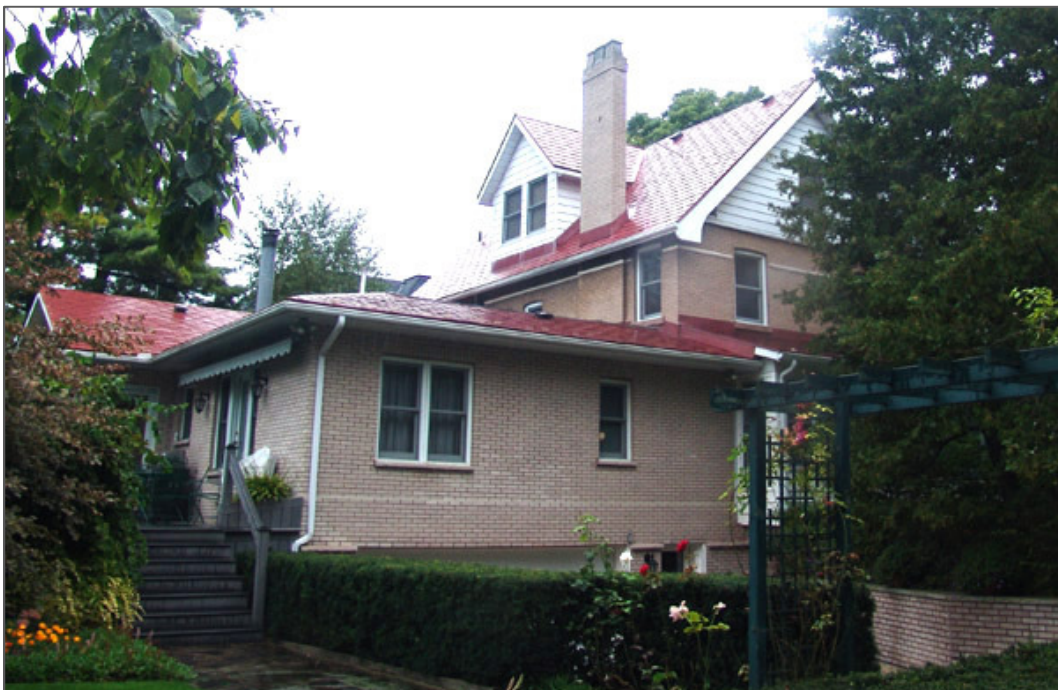
Above: South facade showing enclosed verandah (L); east facade (R)

Below: South (C) and west (L) facades of 1991 rear addition

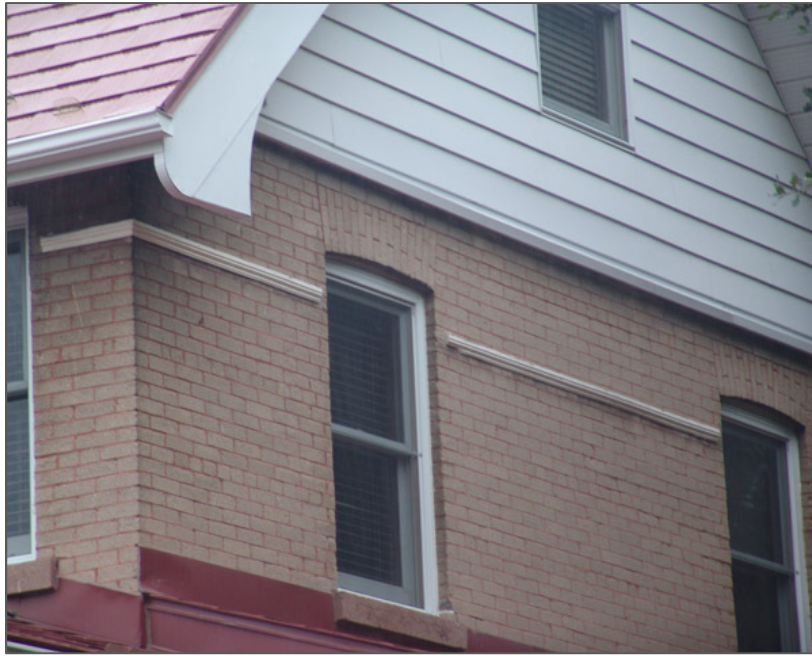
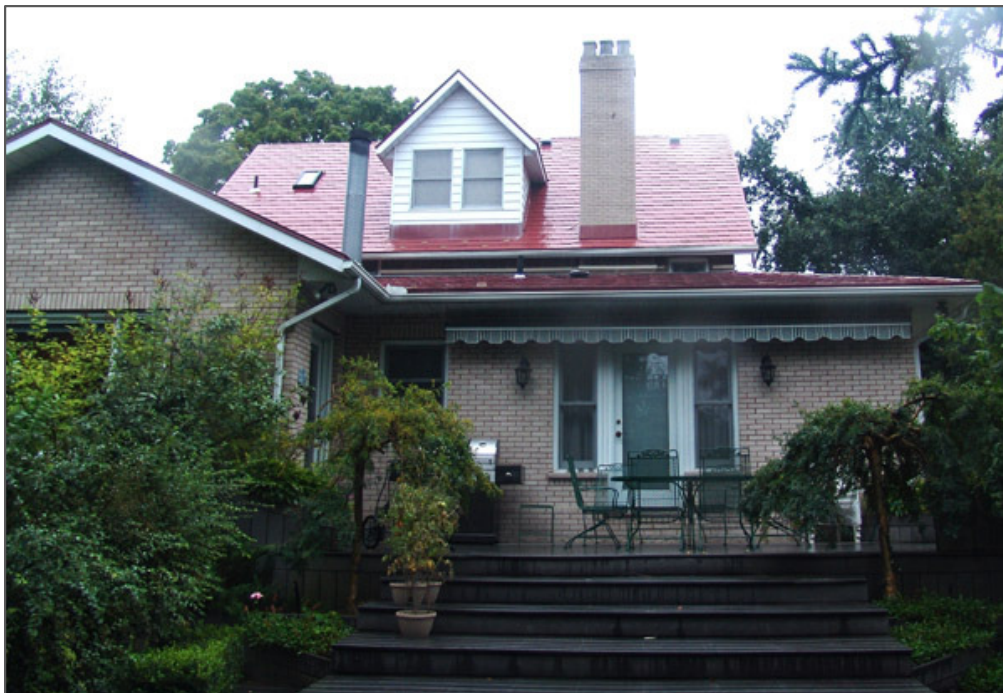
Above: South facade showing gable end formerly plastered and now clad in metal siding; window sash replacing the Queen Anne style sash in the gable; wood trim band applied to brick masonry; segmental window openings with voussoirs or heads

Below: West facade showing 1991 addition in foreground with original dwelling behind

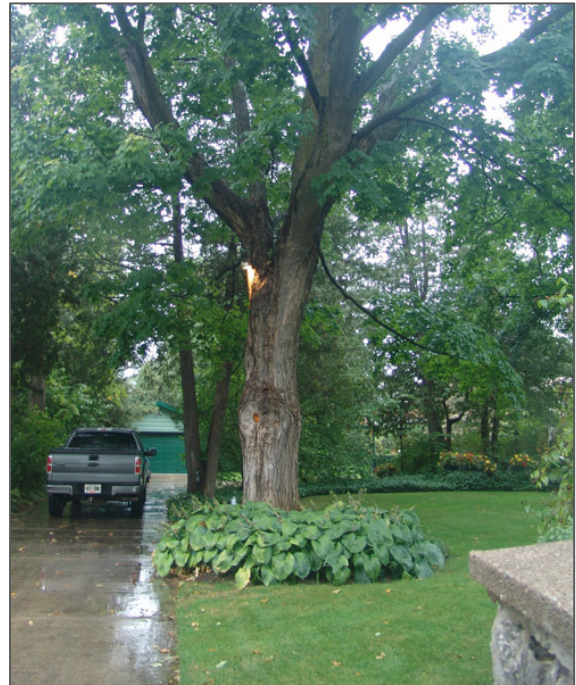
Above: Concrete block wall looking north

The concrete block wall and pillars with a wood pergola (entryway) along the Ste. Marie streetscape is believed to be an original or early feature.

In the 1950s images, the textured face of the block appears to be more distinct and regular. The change in appearance to 2010 may be due to erosion of the surface detail. Some of the blocks in the south section have been replaced with similar materials.

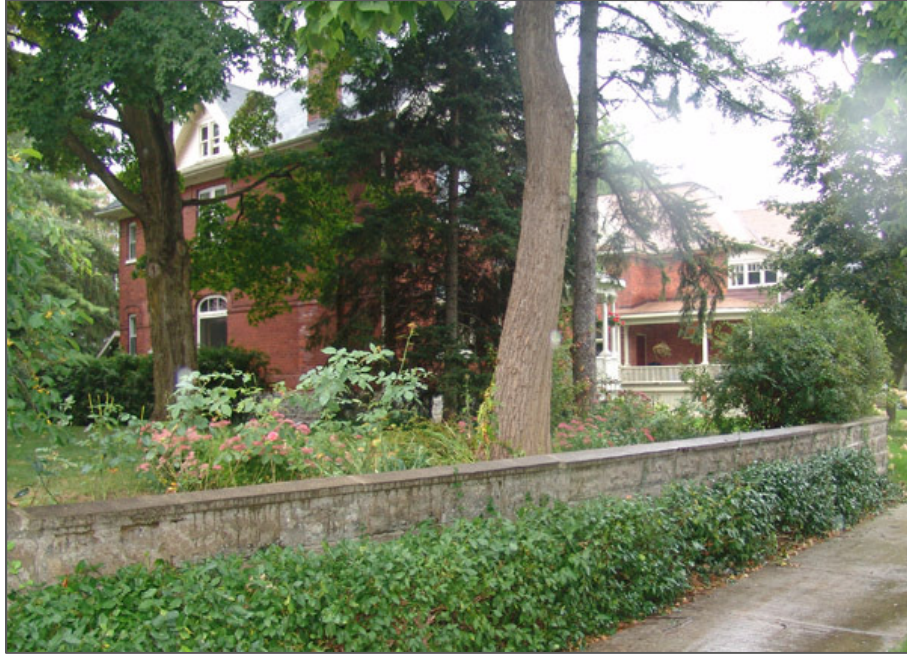
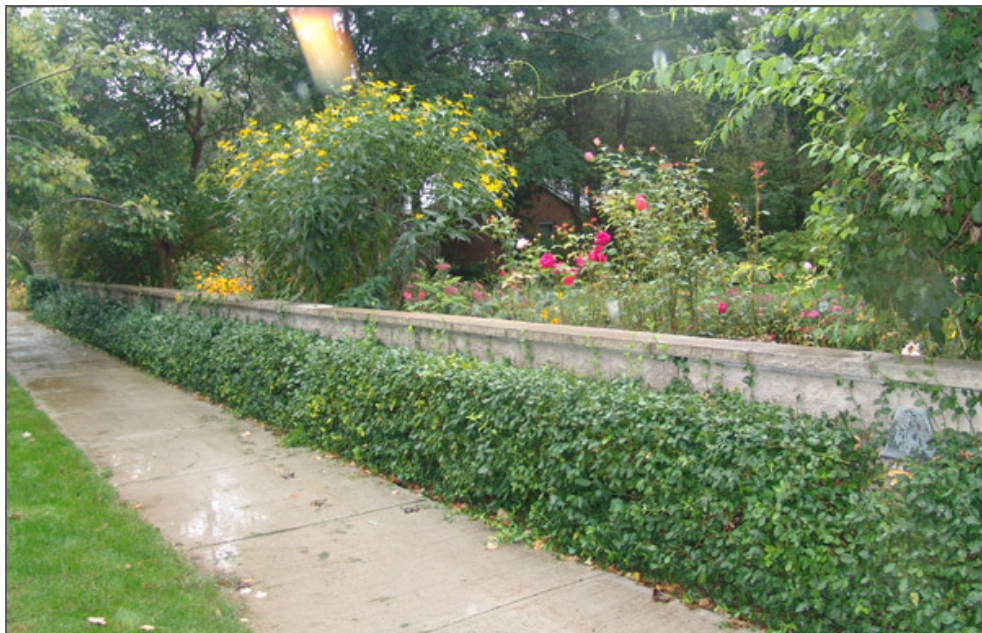
Below: Concrete block wall looking south

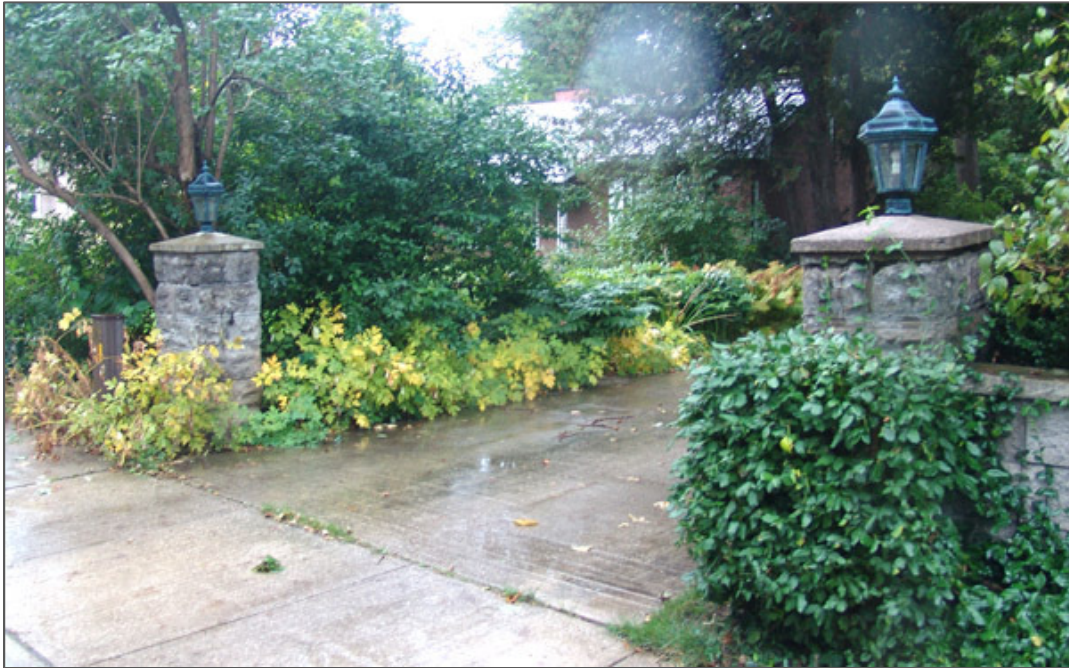
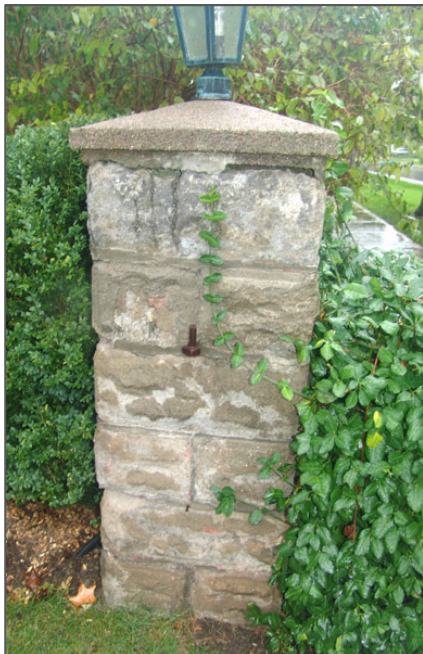
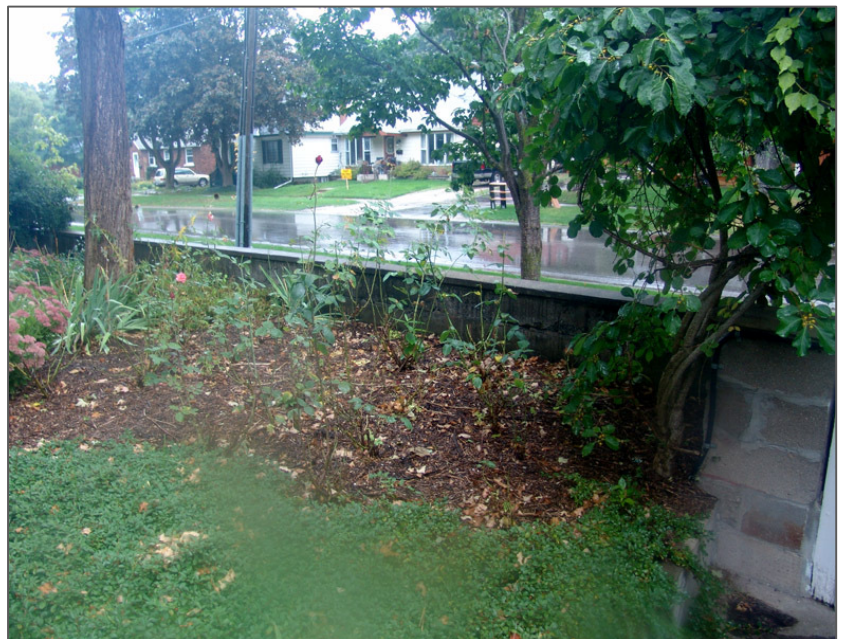
Above: Concrete block pillars flanking the driveway at south end of property

Below Left: Concrete block pillar showing metal pintle for a gate

Below Right: Inside face of concrete block wall, north of the pergola

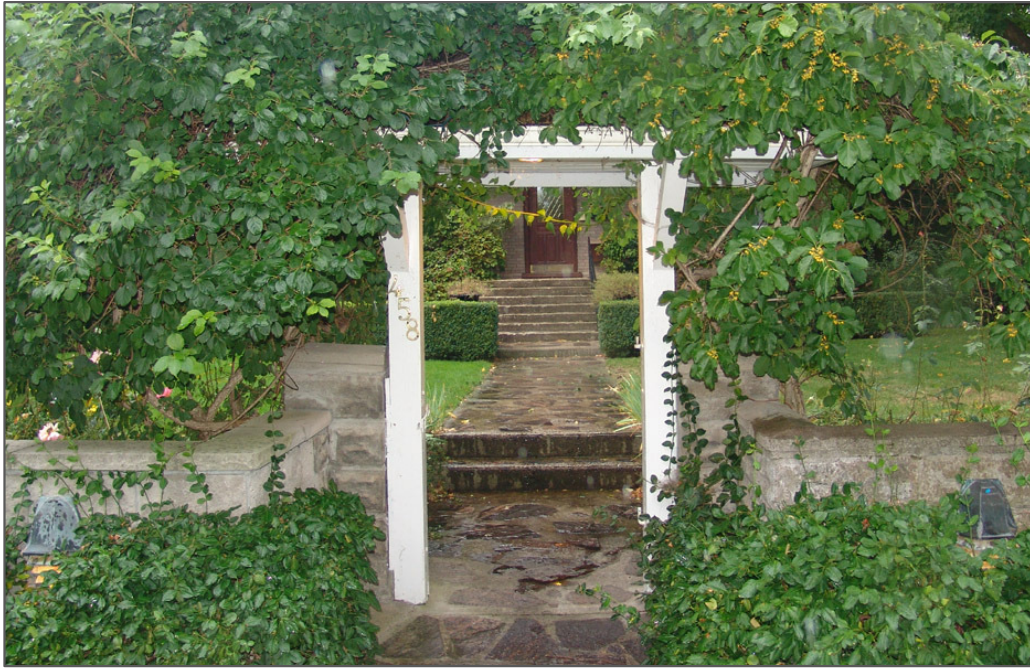
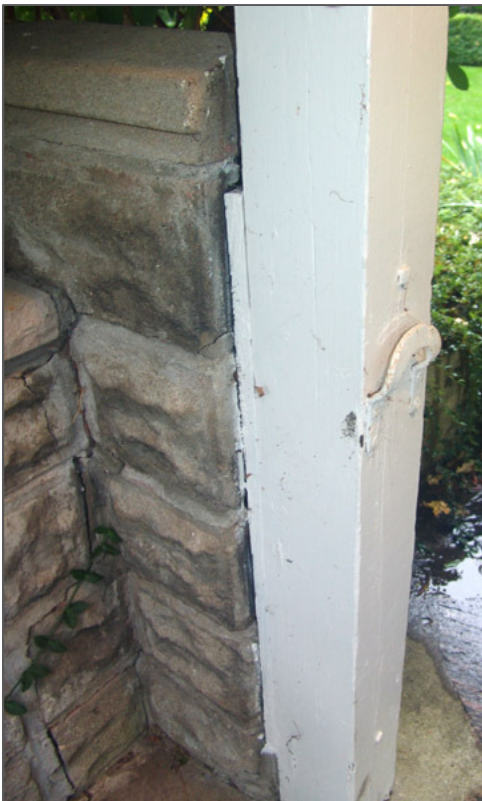
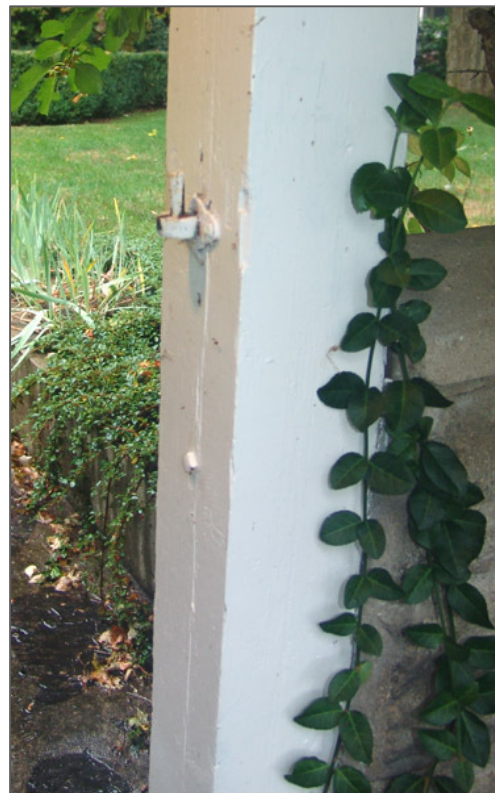
Above: Street side of pergola

Below Left: Hardware for gate on north support post of pergola

Below Right: Hardware for gate on south support post of pergola

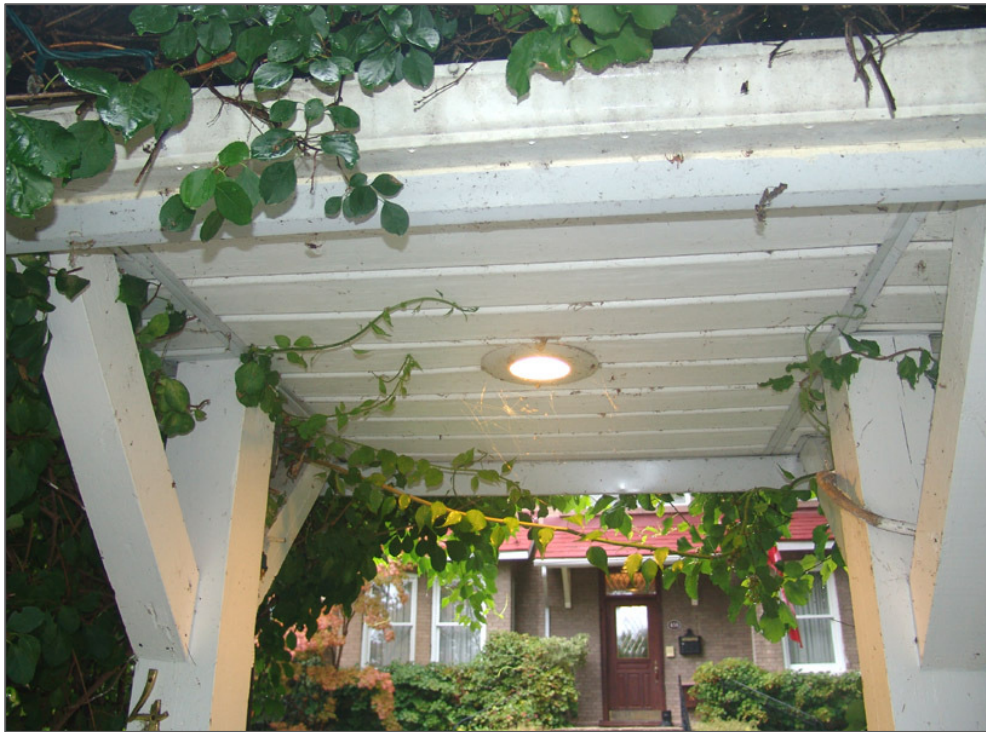
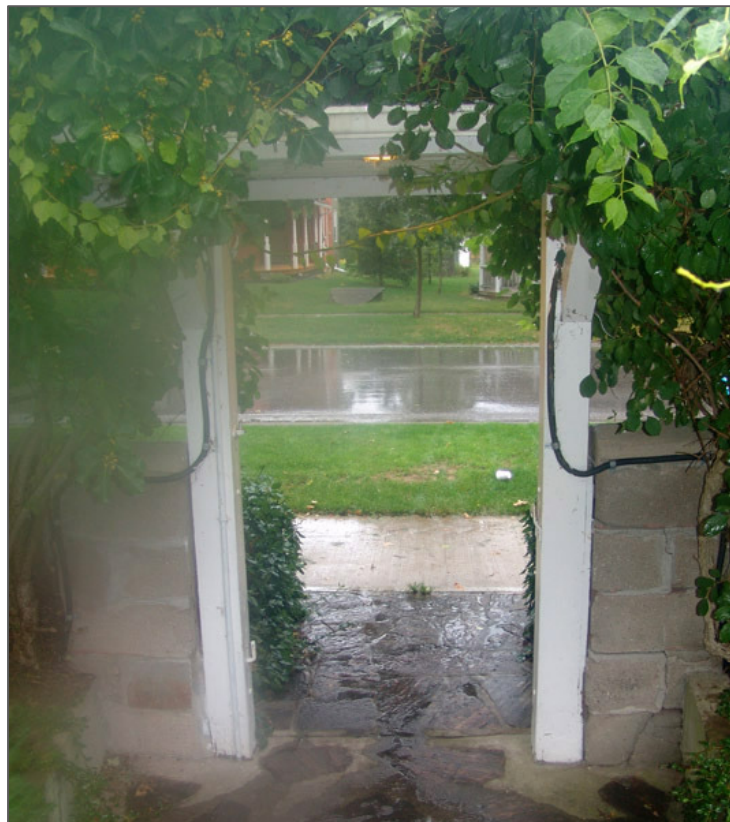
Above: Roof structure, Y-brackets, and support posts of pergola

Below: Inside of pergola

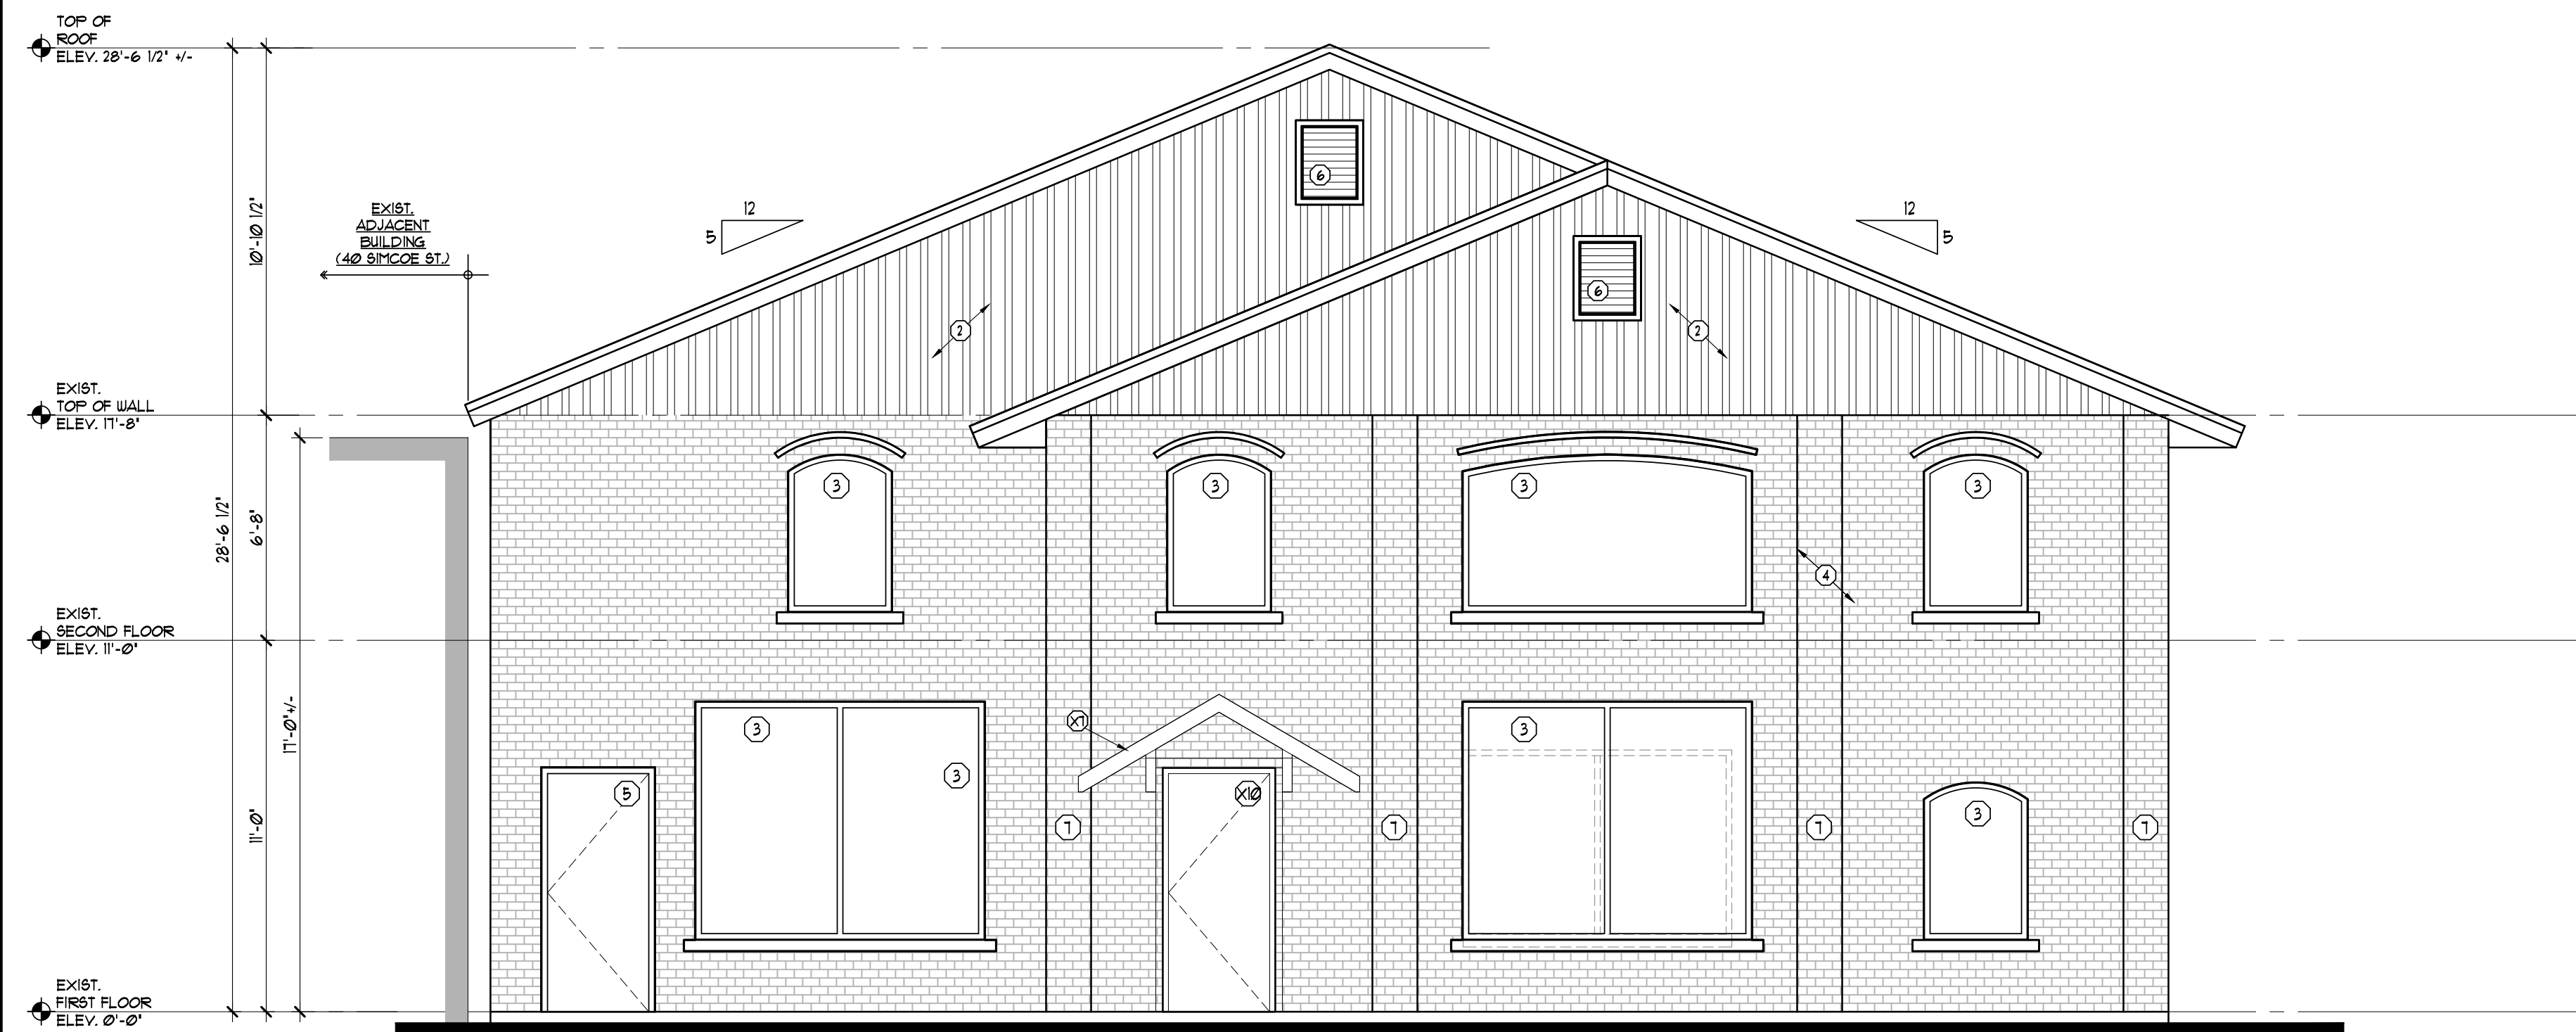
PROPOSED NORTH ELEVATION

PROPOSED WEST ELEVATION

THAT the Collingwood Heritage Committee recommend approval of the Heritage Permit Application PLHP2025223 for a new gable roof and alterations to the north and west elevations in accordance with “Proposed North and West Elevations” drawing number A4 by Barill Engineering Limited dated March 28, 2024, subject to the following conditions:

1. The door for the new entrance on the north/Simcoe Street elevation shall be wood or wood-look;
2. All siding shall have a wood texture and be a colour from the Town-approved heritage colour palette;
3. That any decorative brickwork original to the building that may remain be retained to the greatest extent possible;
4. That where any new brick is required, it shall match the existing in strength, size, colour, and texture as closely as possible; and
5. That lime-based mortar shall be used for repointing of original masonry.
