Hurontario Street Parking Study

Town of Collingwood

Date:	February 4 th , 2026	Client:	Town of Collingwood
Project Name:	Collingwood Master Mobility & Transportation Plan	Project No.:	BRM-23015411-A0
To:	Ed Dujlovic, P.Eng., Project Manager, Town of Collingwood	From:	Rick Zarzosa, P.Eng., Project Manager, EXP Services Inc.
Written By:	The EXP Transportation Team	Draft Memorandum

Subject: Hurontario Street Study and Active Transportation Opportunities

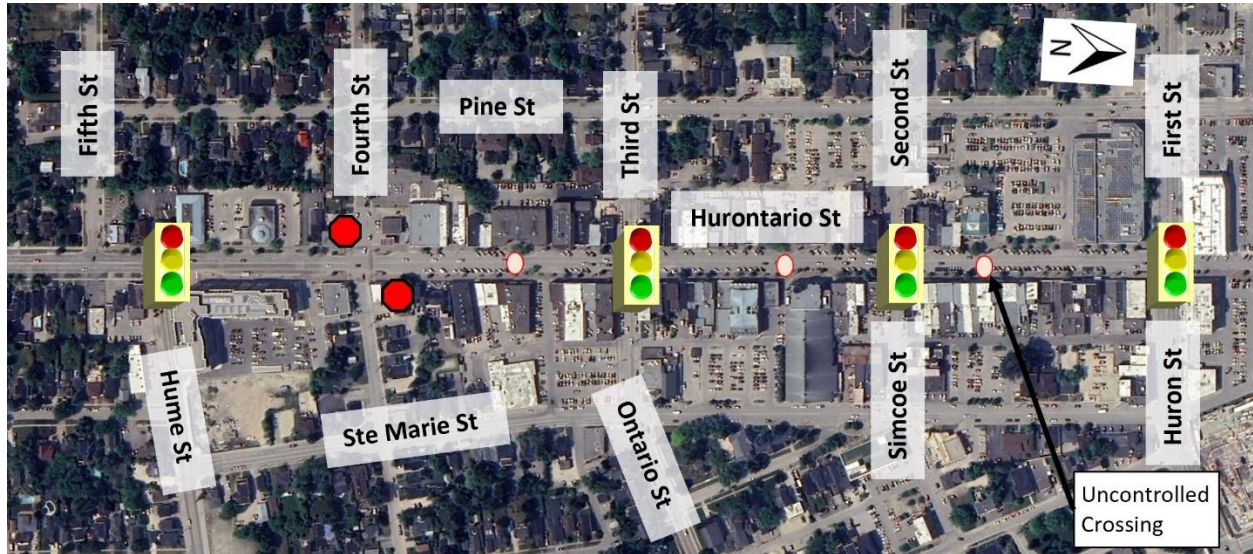
Figure 1 - Study Area

The study area, presented in **Figure 1**, comprises Hurontario Street from First Street/Huron Street to Hume Street. The road segment is approximately 850 m long. No known future development will be accounted for in the immediate area.

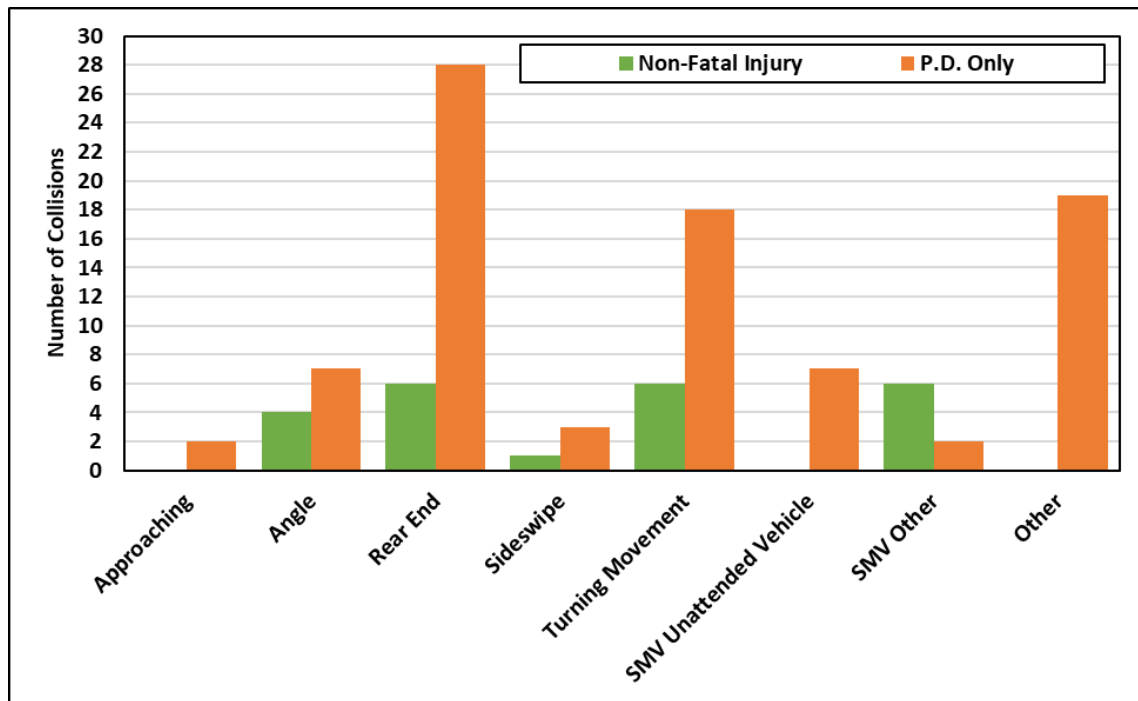
Figure 2 - Collision Severity by Collision Type

Figure 2 breaks down the collisions within the study area based on collision type and severity. Of the 109 recorded collisions, 23 (21%) resulted in an injury. The figure shows that four angle, six rear end, one sideswipe, six turning movement, and six single motor vehicle collisions resulted in an injury. It should be noted that the pedestrian collisions fall under SMV collisions.

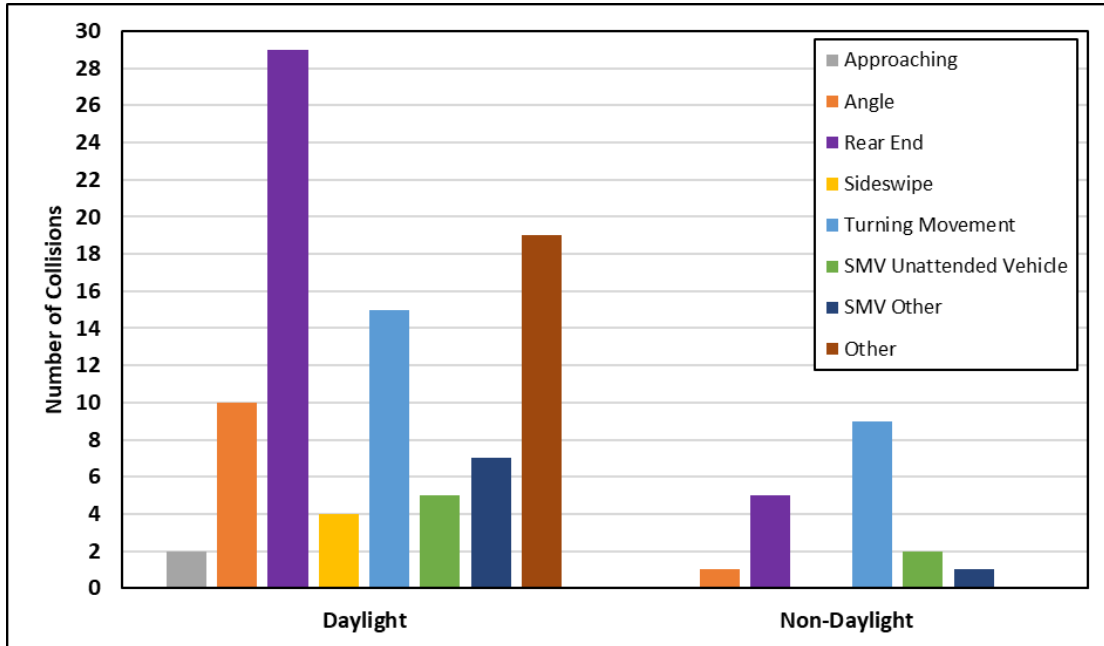
Figure 3 - Lighting Condition by Collision Type

Figure 3 illustrates the lighting by collision type at the time of the accident. In total, 18 collisions (17%) occurred during darkness, at dawn, or at dusk. In total, one angle, five rear end, nine turning movement, two SMV unattended vehicle, and one SMV collisions occurred during non-daylight conditions. This may show an overrepresentation of turning movement collisions during darkness as 38% of turning movement collisions occur under those conditions. By looking at each location individually in Table 3, we can note that collisions occurring in darkness are spread throughout the corridor and do not show a pattern.

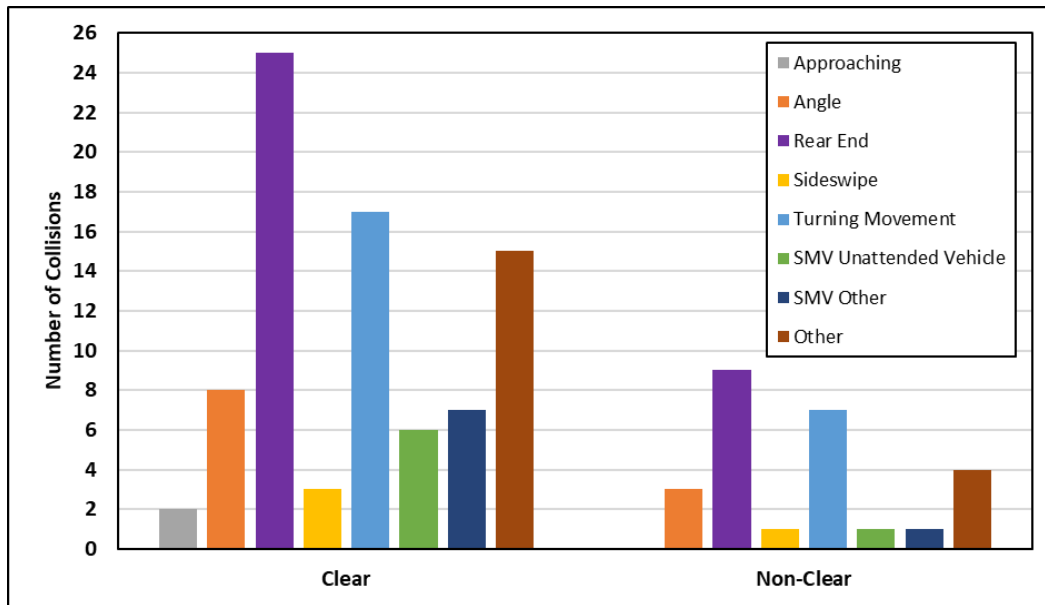
Figure 4 - Environmental Conditions by Collision Type

Figure 4 illustrates collisions by the environmental condition at the time of the accident. In total, 83 collisions (76%) occurred when it was clear and the remaining 26 occurred during rain, snow, or freezing rain. By looking at each location individually in Table 3, it can be noted that collisions occurring during adverse weather conditions are spread throughout the corridor and do not show a pattern (although none occurred between First Street and Second Street).

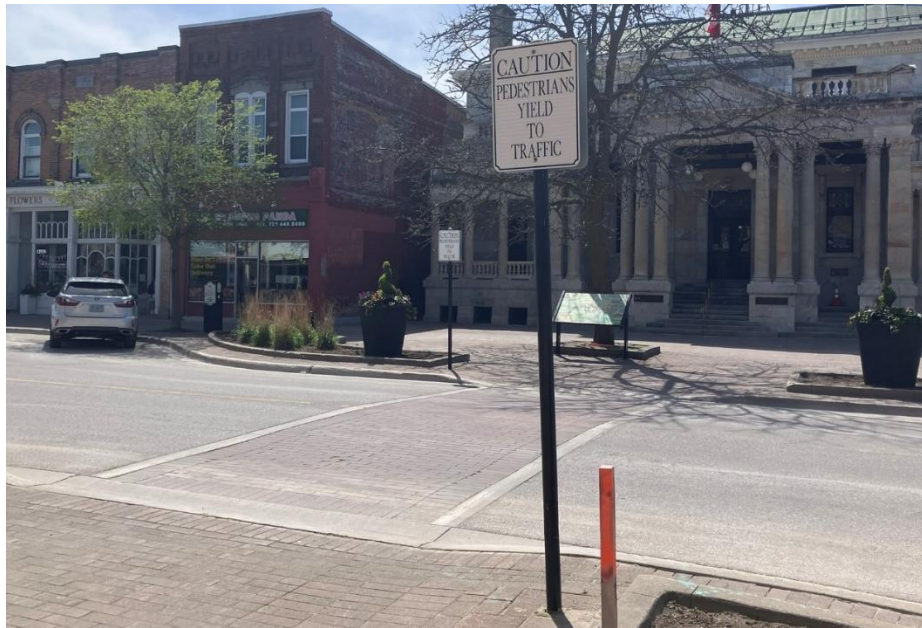
Figure 6 - Uncontrolled Crossing on Hurontario Street between First Street & Second Street

Sidewalks are provided on both sides of the road and there are three uncontrolled pedestrian crossings with curb extensions at midblock locations along the corridor (see **Figure 1** for locations). Uncontrolled crossings do not have traffic control measures and drivers are not required to yield to pedestrians. Instead, pedestrians must use their judgement to wait for a safe gap in traffic to cross. There are also uncontrolled crossings for pedestrians to cross Hurontario Street at Fourth Street (there is no traffic control for vehicles on Hurontario Street and Fourth Street is stop controlled). These uncontrolled crossings are marked with near side and far side non-standards signs that read “CAUTION PEDESTRIANS YIELD TO TRAFFIC” as shown in **Figure 6**. As a guideline, *OTM Book 15 – Pedestrian Crossing Treatments* states that uncontrolled crossings must not be considered if the road classification is higher than a collector road. Additionally, the uncontrolled crossings lack AODA (The Accessibility for Ontarians with Disabilities Act) features such as tactile plates at the bottom of the ramps. Given Hurontario Street is considered an arterial road with high traffic volumes, a controlled crossing may be appropriate at some or all the uncontrolled crossing locations along the corridor. This would improve pedestrian safety, accessibility, and connectivity. It is noted that the requirement of having a minimum 200 m between a pedestrian crossover (PXO) and other signal-protected pedestrian crossings, specified in *OTM Book 15* and the Town’s *Crosswalk Policy*, may preclude them from being implemented.

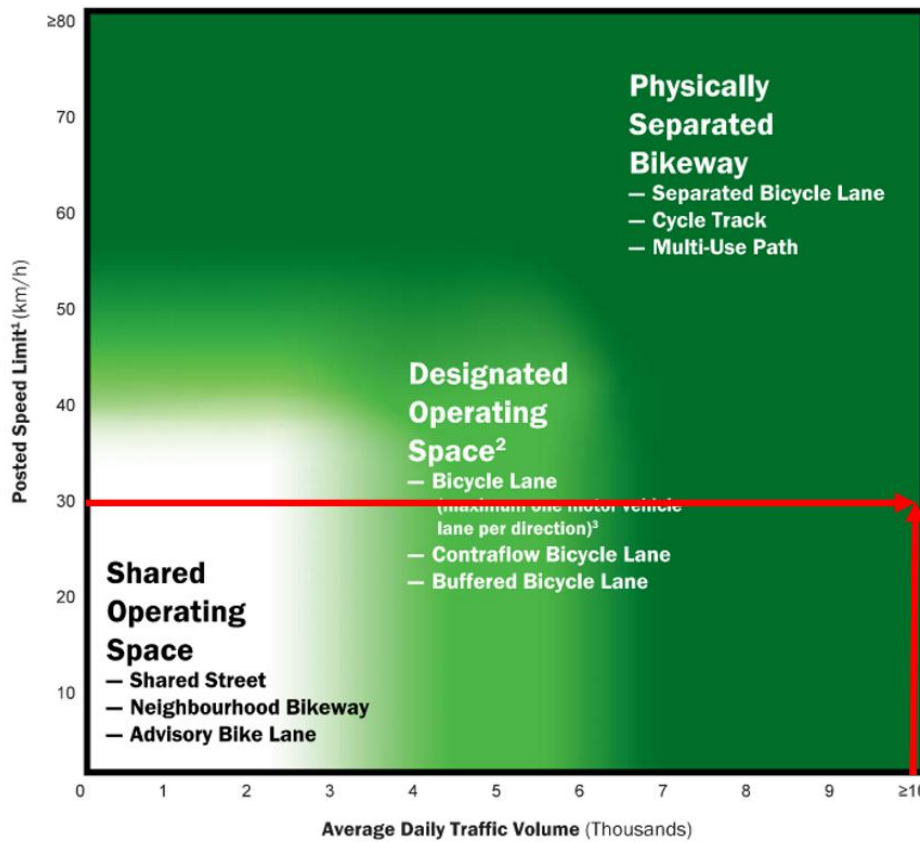
Figure 7 - Desirable Cycling Facility Pre-Selection Nomograph (Urban / Suburban Context)⁷

The first step is to pre-select the facility type options using the nomograph provided in *OTM Book 18* for the urban / suburban context. The nomograph uses average daily traffic volume and posted speed limit as the input parameters. For Hurontario Street, the average daily traffic volume is 15,000 vehicles per day⁶ and the posted speed limit is 30 km/h. The inputs plotted on the nomograph, as displayed in **Figure 7**, show that a physically separated bikeway (separated bicycle lane, cycle track, or multi-use path) is most desirable for the cycling facility along the corridor.

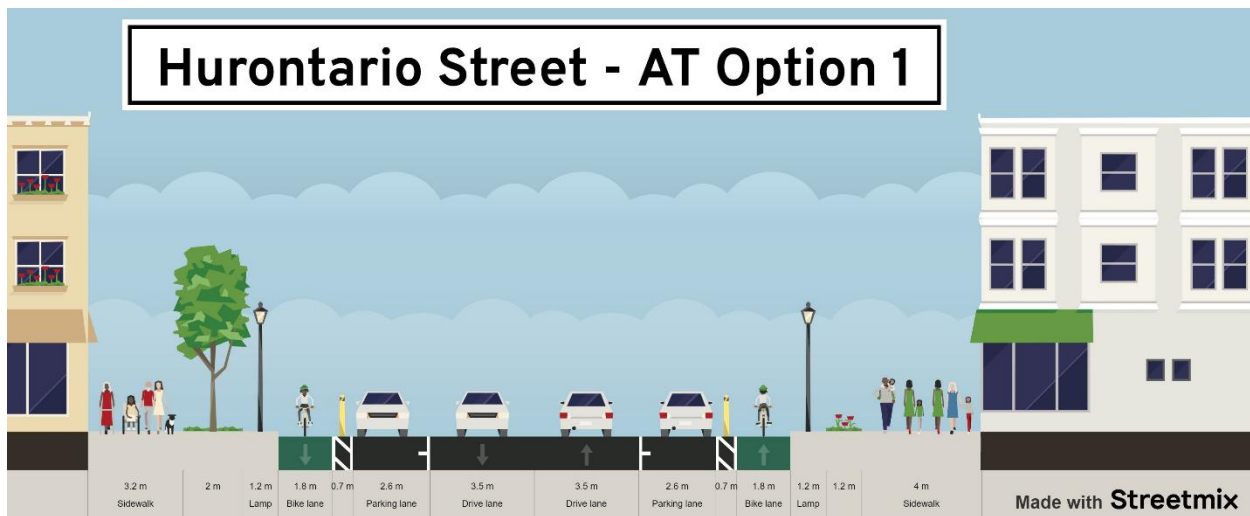
Figure 8 - Hurontario Street Active Transportation Facility Option

- The existing pavement width is approximately 17.2m where there is parking on both sides of the road.
- Two vehicle driving lanes (one northbound and one southbound) at 3.5m wide.
- Two parallel parking lanes (one northbound and one southbound) at 2.6m wide.
- Two physically separated bike lanes (one northbound and one southbound) at 1.8m wide.
- A buffer between the parking and bike lanes (minimum 0.6m wide). *OTM Book 18* specifies the minimum buffer width should be 0.6m when the bike lane is adjacent to a parking lane.
- Flexible bollards installed as the separation technique in the buffer between the parallel parking lane and the bike lanes. Removable rubber curbs or pre-cast concrete curbs could also be considered to supplement the bollards.

Additional impacts and design considerations for implementation of the typical cross-section illustrated in **Figure 8** include the following. One of the primary considerations is the variation in pavement width along the corridor. **Figure 9** shows the differences in pavement width at intersections and uncontrolled pedestrian crossings (note measurements are approximate).

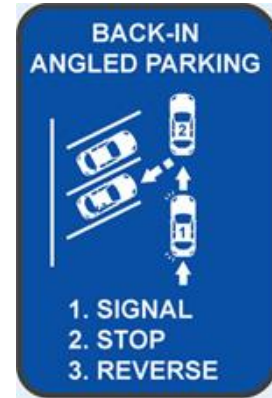
Figure 12 - Back-In Angled Parking Guidance

The potential drawbacks of back-in angled parking can be countered with the installation of clear signage and public engagement/education. One of the primary concerns with back-in angled parking is that it can cause traffic delays when vehicles are waiting for another vehicle to park. However, this is also the case with pull-in angled parking (when exiting) and parallel parking. Another concern is that since back-in angled parking is less common, drivers will have less familiarity with it. Town residents will become more comfortable with the parking maneuver over time but since the Town receives many visitors, especially during the summer months, there will always be motorists that are unfamiliar with it. However, backing into a parking space is typically easier than parallel parking. Additionally, signage can be posted (an example is shown in **Figure 12**¹⁰), and educational materials can be prepared online and in print to instruct road users on how to properly do it. Finally, a significant concern is that vehicles may cross the road to park nose first into the parking space, creating a substantial safety issue when they exit the parking space as they would either need to back out across a lane of traffic, or swing more than 90 degrees to back out, a maneuver that would have poor sightlines of conflicting traffic and would be difficult to perform without encroaching on adjacent parking spaces or the opposing lane of traffic. This issue could be solved by signage indicating that pulling into the parking spaces is not permitted and that doing so poses a safety risk.
